PUTTING THE BEST FACE ON CAST IRON FAÇADES

Call worked closely with Historical Arts & Castings throughout the restoration of the iconic façade from Zion’s Cooperative Mercantile Institution (ZCMI), founded by Brigham Young in 1868, and now attached to the west face of Salt Lake City’s new Macy’s department store. The 75-foot high by 140-foot long structure features a cornice section made of galvanized sheet metal at the top of the façade, cast iron colonnades with 63 bays for windows and thousands of ornate castings.

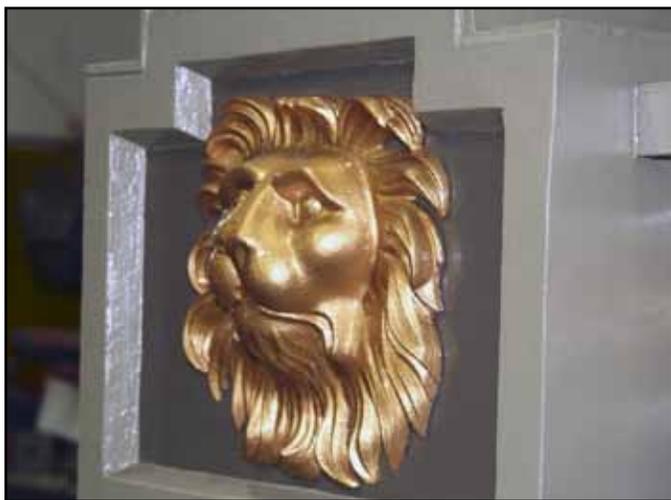
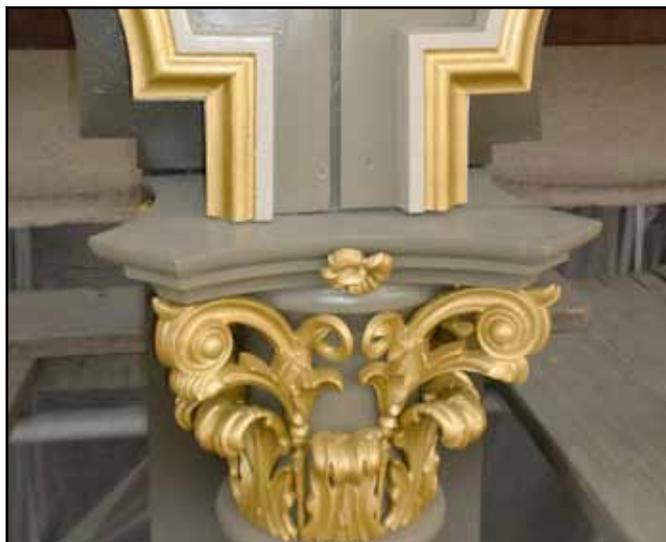
Cast iron colonnades, replacement pieces re-cast in aluminum and ornamental pieces of the façade were prepared by abrasive blast cleaning and shop-primed with an epoxy coating that doubled as field-applied tie coat. Specified primers were Series 66 Hi-Build Epoxoline and Series N69 Hi-Build Epoxoline II. Pitted cast iron pieces were reconditioned using Series 215 Surfacing Epoxy and primed with a coat of Series N69 epoxy. Structural steel used to secure cast iron components to the building was blast-cleaned and primed by the fabricator with Series 90-97 Tnemec-Zinc, a zinc-rich aromatic urethane.

The face of Macy’s department store was surrounded by scaffolding and enclosed to help control environmental conditions while tie-coats, finish coats and the gold accent finishes were brush, roller, and spray applied to the cast iron colonnades and to ornate castings that were then reattached to the façade. Approximately 2,300 hours were required by Daniels Painting, Inc. to complete the field coatings and installation.

Galvanized metal sections of the ZCMI façade were shop-primed with a polyamide epoxy, followed by a finish coat of Series 1072 Fluoronar, a high-solids fluoropolymer resin, in various custom colors. The gold accent was a custom color to simulate 24-karat gold leafing of Series 1078 Fluoronar Metallic that was then coated with Series 1079-0762 Metallic Clearcoat.
