PROJECT PROFILE

City of Billings Water Treatment Plant

Project Name
City of Billings Water Treatment Plant

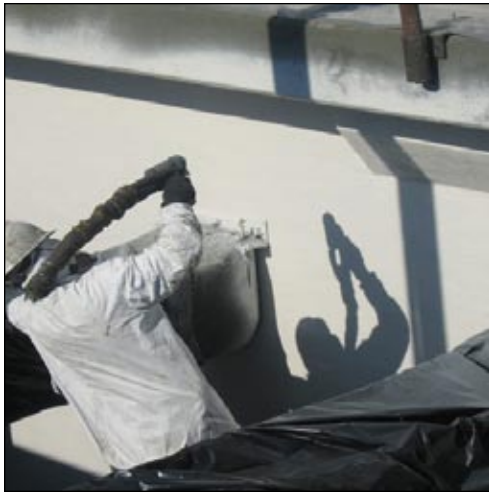
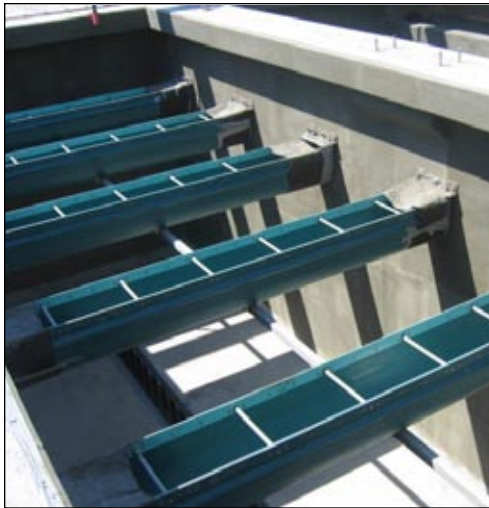
For the new filter basins constructed of poured-in-place concrete at the City of Billings Water Treatment Plant, the polyurea elastomer finish coat was spray-applied using plural component equipment.

Phase I of the project involved coating four new filter basins constructed of poured-in-place concrete. "The contractor began with an abrasive brush blast of the new concrete. We then addressed the bug holes and voids with the resurfacer, which was applied with masonry floats and trowels," Cox recalled. "Then the polyurethane primer was rolled on and the finish coat was spray-applied with heated plural component equipment."
