PROJECT PROFILE

City of Wadsworth Standpipe

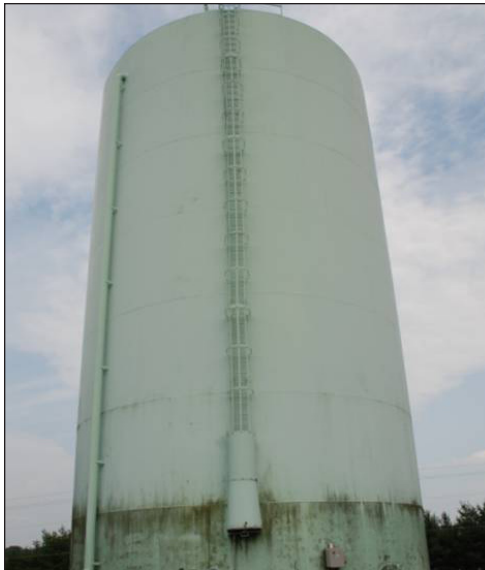
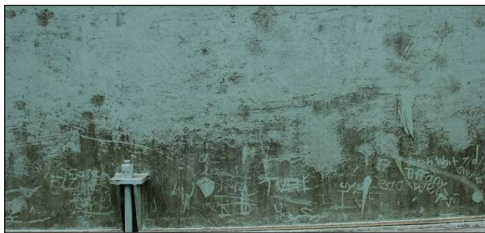
The top two photos show the mold and mildew growing on the Wadsworth standpipe when coated with an acrylic polyurethane system. The bottom photo shows very minor mildew growth due to grass clippings, after a Tnemec fluoropolymer system was applied.

When the City of Wadsworth, Ohio started receiving complaints about mold and mildew growing on a 700,000 gallon standpipe located near a residential neighborhood, engineers replaced its existing acrylic polyurethane exterior coating system with fluoropolymer technology from Tnemec. "Today, city officials are impressed with the fact that they have not had the regrowth of mold and mildew that they saw with the previous coating system," according to Tnemec coating consultant Sean Carlin. "With the old coating, city crews had to go out every year with bleach and a pressure washer to clean off the mold and mildew."
