AEROLON[®]

THERMAL INSULATING COATING

RESISTS CORROSION UNDER INSULATION

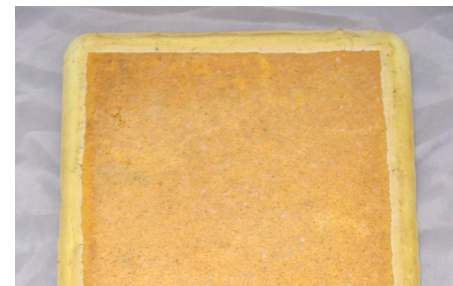
AEROLON TEST PANEL

The Aerolon-coated panel (above) demonstrated excellent corrosion resistance after being submitted to ASTM G85, commonly referred to as "Prohesion." Primed with a zinc-rich urethane, yet left untopcoated, the Aerolon panel was enclosed in a cabinet with vapor composed of 0.05% sodium chloride and 0.35% ammonium sulfate from solution. The panel was exposed – alternately for one hour each – to vapor at 75°F and dry air at 95°F. After 5,000 hours of testing, the Aerolon panel showed no signs of blistering, cracking, rusting, or delamination of film.

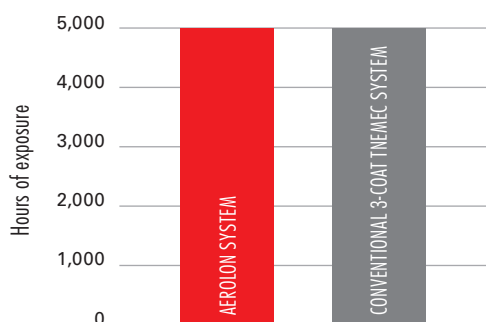
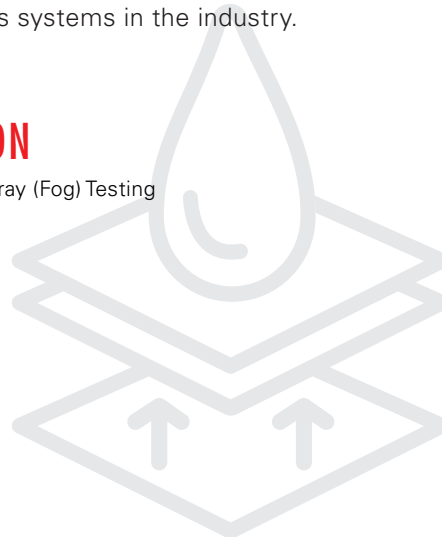
COATINGS SYSTEM COMPARISON

ASTM G85, Standard Practice for Modified Salt Spray (Fog) Testing

This comparison shows that an Aerolon coatings system (1224/971/1028T) is equally as effective at resisting corrosion as a standard 3-coat Tnemec system (394/66/73) designed specifically for this purpose. Both systems showed no signs of blistering, cracking, rusting, or delamination of film after 5,000 hours of testing.

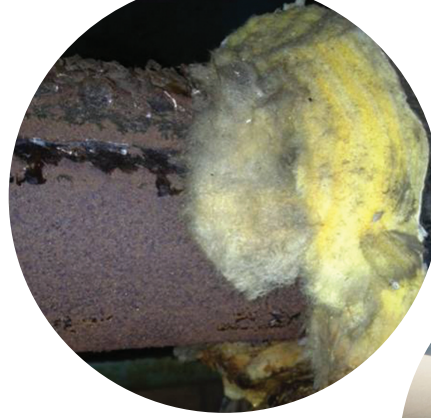
INITIAL CUI DAMAGE

The flooding of a Nashville, Tennessee water treatment plant led to the discovery of significant corrosion under insulation (right), which otherwise, may have continued to go unnoticed, causing even more widespread, irreparable damage. A coatings system featuring Aerolon was applied to the pipelines (far right) in order to prevent future incidence of corrosion. The application included a water-based corrosion-resistant epoxy primer, Series 971 Aerolon Acrylic and a high-performance topcoat.

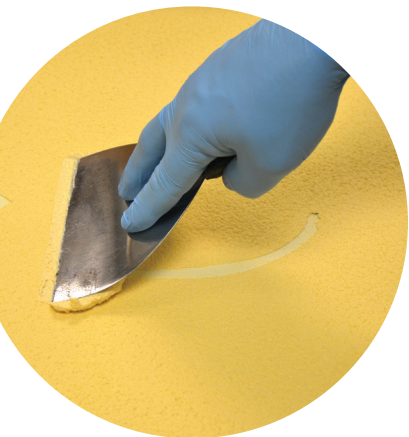
These images show how easily Aerolon can be spot-repaired with a trowel when gouged or damaged, rather than requiring whole sections to be repaired or replaced as necessary with many other types of insulation. The ability to easily and very cost-efficiently restore the coating's integrity with a simple touch-up is a big advantage in extending life cycles. Contact a Tnemec Technical Service Representative for detailed repair instructions.

1. APPLY AEROLON TO
DAMAGED AREA.

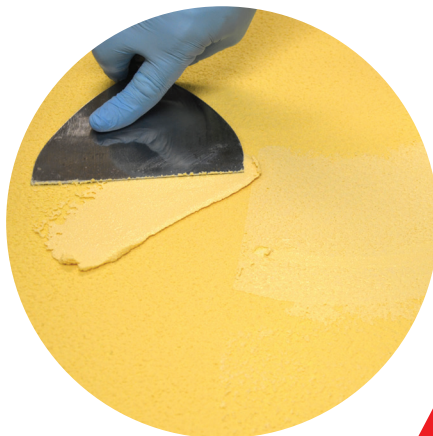
2. SMOOTH AND FINISH
APPLICATION.
