# 100 FEDERAL STREET CHILLER TANK

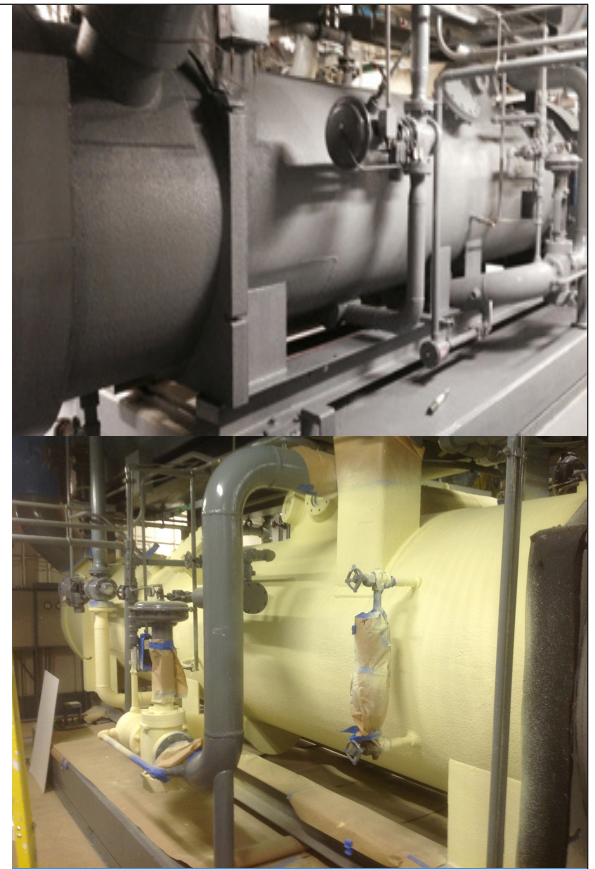
Before being coated with Tnemec’s thermal insulating coating, Aerolon, the chiller tank’s foam insulation was allowing moisture to penetrate and cause accelerated corrosion.

The chiller tank received a prime coat of Series 1224 Epoxoline WB, a low odor and low VOC, water based epoxy coating, roller-applied to the steel prepared in accordance with SSPC-SP 3 Power Tool Cleaning. Following Series 1224, the owner applied Tnemec’s advanced-generation thermal insulating coating, Series 971 Aerolon Acrylic, using a texture spray gun. This coating can be easily applied in a high-build, thick coat to help prevent the harmful effects of condensation and CUI.

Once cured, the system was completed with a roller-applied topcoat of Series 1028T Enduratone. This acrylic polymer coating provides long term protection and is available in a wide variety of colors. Once applied and cured, this Aerolon system created one continuous coat on the tank where the former insulating material left gaps and seams.
