PROJECT PROFILE

Taylorville Water Tank

Project Name
Taylorville Water Tank

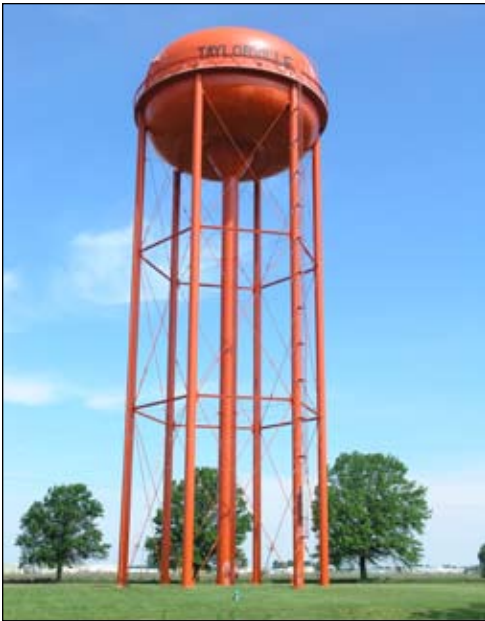
After 15 years of exposure, the Taylorville water tank is still as shiny and orange as the day it was coated!

Surface preparation for the tank consisted of abrasive blast cleaning in accordance with SSPC-SP10 (interior) and SSPC-SP6 (exterior) to remove the original coatings. Once the interior was blasted, two coats of Series 20 Pota-Pox, a polyamide epoxy primer, were spray-applied at 4.0 to 6.0 mils DFT per coat. On the exterior, Series 65, a polyamide epoxy, was used as a prime coat at 2.0 to 3.0 mils DFT, followed by an intermediate coat of Series 66 Hi-Build Epoxoline, a polyamide epoxy applied by roller at 2.0 to 3.0 mils DFT. A finish coat of Series 73 Endura-Shield, an aliphatic acrylic urethane, was applied in orange at 2.0 to 3.0 mils DFT and a clear topcoat of Series 76 Endura-Clear at 1.0 to 1.5 mils DFT completed the job.

"This was one of the first tanks where we used a complete clear coat on the tank's exterior," Otten recalled. "Prior to this tank, the clear coat was typically applied only on lettering and logo. Back in the early 1990s, for long term color and gloss retention, especially with dark or accent colors, a final coat of a UV absorbing, acrylic polyurethane clearcoat was our best option and it worked very well. Today, after 15 years of exposure, the tank is still as shiny and orange as the day it was coated."
