PROJECT PROFILE

Crestview Water Tank

Project Name
Crestview Water Tank

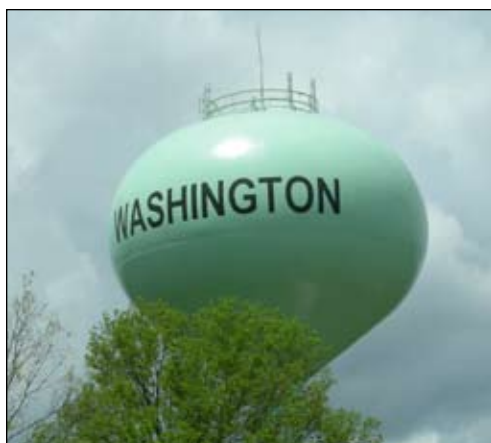
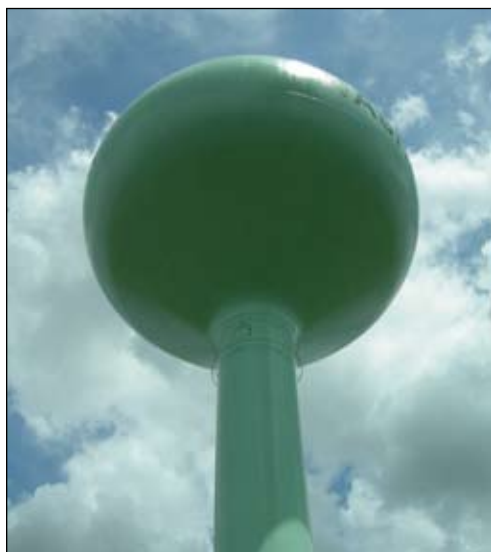
Series 1028 Enduratone, a High Dispersion Pure acrylic polymer, was chosen to protect the exterior of the water tank in Crestview, MO because it could be roller applied and still maintain dryfall characteristics.

After the exterior of a local 500,000 gallon pedisphere featuring a millennium logo started to slightly fade, the city decided the tank needed to be refreshed in the fall of 2006. Any areas exhibiting minimal rust were prepared in accordance with SSPC-SP3, followed by a spot prime coat of Series 27 F.C. Typoxy, a fast-curing, versatile polyamide epoxy. Next, two coats of Series 1028 Enduratone, a High Dispersion Pure acrylic polymer, were brush and roller applied to the entire exterior. A water-based, low VOC coating that provides excellent long-term protection, Series 1028 is mildew resistant, exhibits very good gloss and color stability, and may be spray, brush or roller applied to achieve dryfall. The product may also be used over many aged coatings, which was the case with the Crestview tank which had been previously coated with an acrylic polymer.

Due to the location of the tank being in a residential neighborhood, the owner did not want the exterior coating system to be spray applied. By rolling Series 1028, the owner's wishes were met while still maintaining dryfall characteristics. The applicator reports that Series 1028 was very easy to roll and had excellent coverage.
