PROJECT PROFILE

Earlywine Family Aquatic Center

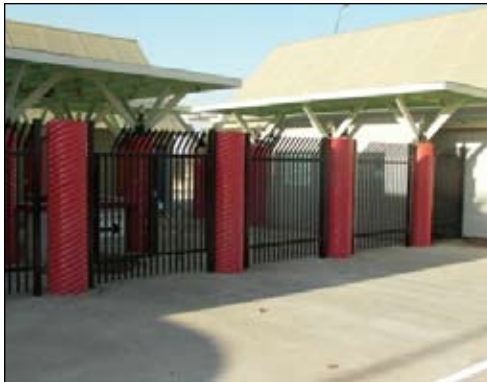
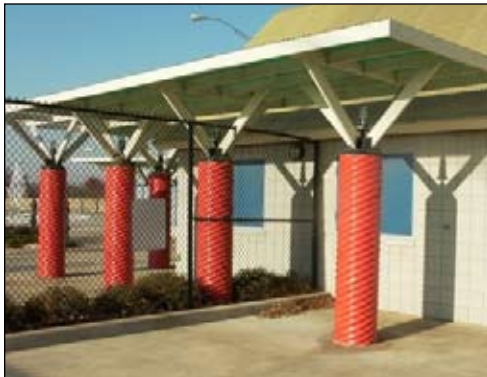
Tnemec and Chemprobe coatings protect the building and entryway at the Earlywine Family Aquatic Center in Oklahoma City, OK.

Series 660 Prime-A-Pell 200 and Series 607 Conformal Stain were applied to the building's exterior, including the shower area. Concrete, stone and masonry treated with Prime-A-Pell 200, a solvent-borne modified siloxane water repellent, resist water intrusion, stain damage, freeze/thaw spalling, efflorescence and rust damage. An acrylic coating, Conformal Stain repels water from dense surfaces and does not alter the natural texture of the surface.

Tnemec coatings were also applied to the entryway's fence and architectural columns. Series 66 Hi-Build Epoxoline, a polyamide epoxy, was applied as the primer, followed by an intermediate coat of Series 1075 Endura-Shield II, an acrylic polyurethane highly resistant to abrasion, wet conditions, corrosive fumes and exterior weathering. A topcoat of Series 76 Endura-Clear, an acrylic polyurethane clear coat, was applied to extend the long-term weathering qualities of Endura-Shield.
