# AEROLON<sup>®</sup>

## THERMAL INSULATING COATING

### RESISTS CORROSION UNDER INSULATION

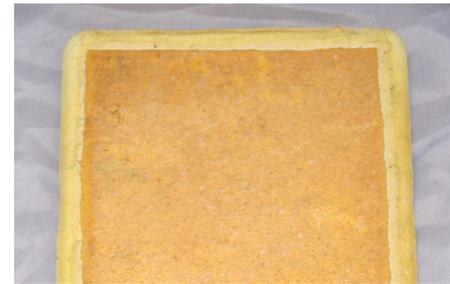
### AEROLON TEST PANEL

The Aerolon-coated panel (above) demonstrated excellent corrosion resistance after being submitted to ASTM G85, commonly referred to as "Prohesion." Primed with a zinc-rich urethane, yet left untopcoated, the Aerolon panel was enclosed in a cabinet with vapor composed of 0.05% sodium chloride and 0.35% ammonium sulfate from solution. The panel was exposed – alternately for one hour each – to vapor at 75°F and dry air at 95°F. After 5,000 hours of testing, the Aerolon panel showed no signs of blistering, cracking, rusting, or delamination of film.

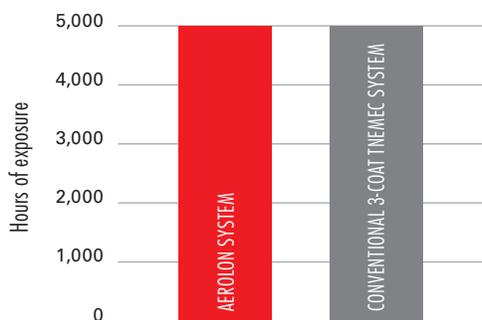
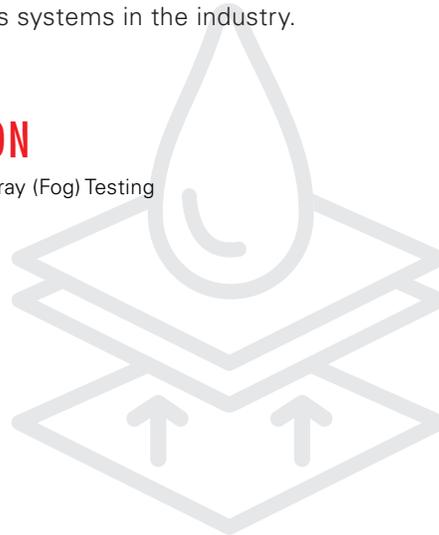
## COATINGS SYSTEM COMPARISON

ASTM G85, Standard Practice for Modified Salt Spray (Fog) Testing

This comparison shows that an Aerolon coatings system (1224/971/1028T) is equally as effective at resisting corrosion as a standard 3-coat Tnemec system (394/66/73) designed specifically for this purpose. Both systems showed no signs of blistering, cracking, rusting, or delamination of film after 5,000 hours of testing.

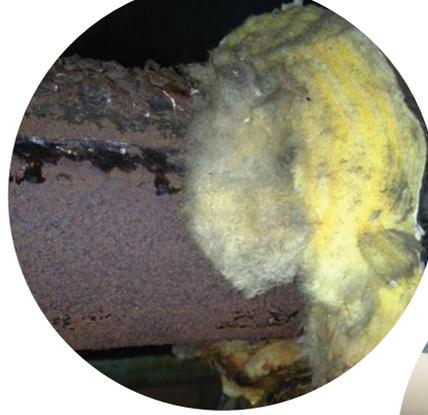
INITIAL CUI DAMAGE

The flooding of a Nashville, Tennessee water treatment plant led to the discovery of significant corrosion under insulation (right), which otherwise, may have continued to go unnoticed, causing even more widespread, irreparable damage. A coatings system featuring Aerolon was applied to the pipelines (far right) in order to prevent future incidence of corrosion. The application included a water-based corrosion-resistant epoxy primer, Series 971 Aerolon Acrylic and a high-performance topcoat.

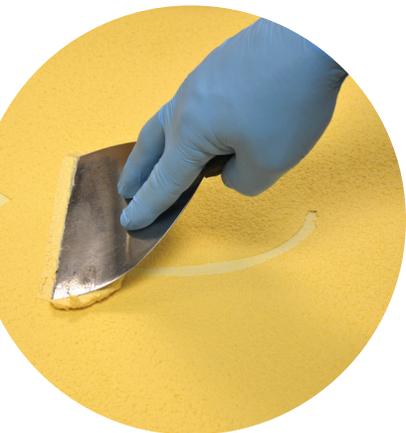
These images show how easily Aerolon can be spot-repaired with a trowel when gouged or damaged, rather than requiring whole sections to be repaired or replaced as necessary with many other types of insulation. The ability to easily and very cost-efficiently restore the coating's integrity with a simple touch-up is a big advantage in extending life cycles. Contact a Tnemec Technical Service Representative for detailed repair instructions.

1. APPLY AEROLON TO  
DAMAGED AREA.

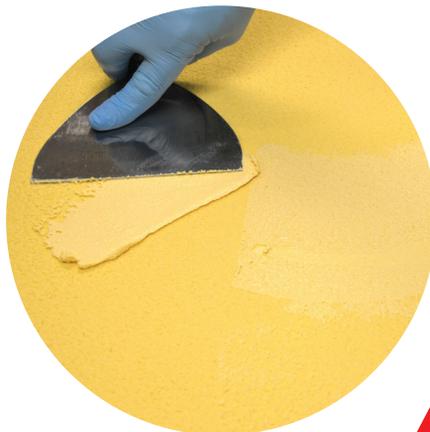
2. SMOOTH AND FINISH  
APPLICATION.
