BELLEVUE WATER TANK

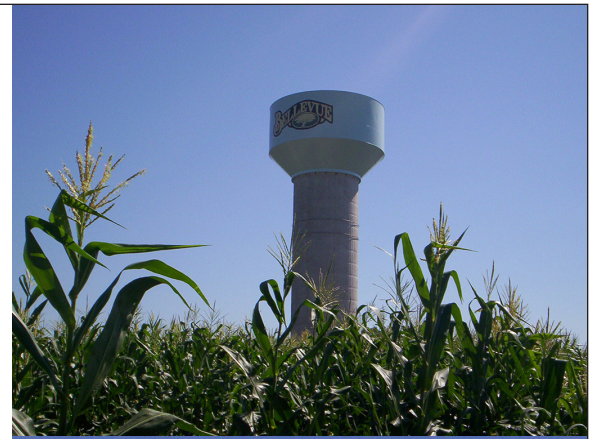
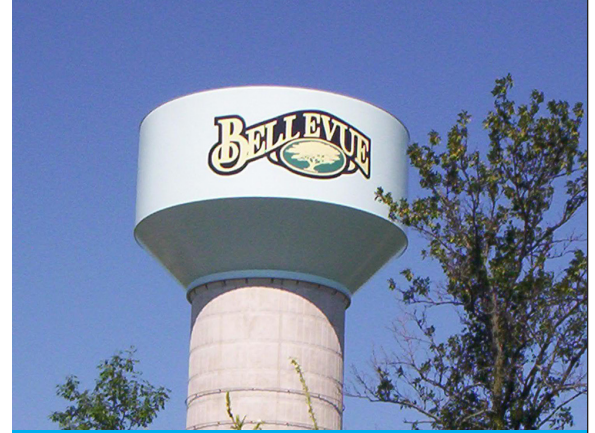
Series 700 HydroFlon provides excellent color and gloss retention for the exterior steel of the 1 million gallon water tank in Bellevue, Wisconsin, while Series 626 Dur A Pell GS protects the tank's concrete pedestal base from graffiti.

Exterior steel was prepared in accordance with SSPC-SP6/NACE No. 3 Commercial Blast Cleaning, then primed with Series 91-H₂O Hydro-Zinc, a two-component, moisture-cured, aromatic urethane zinc-rich primer. Next, the tank's exterior received an intermediate coat of Series 73 Endura-Shield, an aliphatic acrylic polyurethane, which was spray-applied to provide additional film thickness for corrosion resistance. Series 700 HydroFlon, a fluoropolymer polyurethane, was roller-applied as the topcoat using colors from the Village of Bellevue's logo.

Series 660 Prime-A-Pell 200, a solvent-borne siloxane water repellent, was spray-applied to the concrete pedestal base of the tower to protect it from rain and freeze/thaw spalling. "Series 626 Dur A Pell GS was then applied to the bottom 12 feet of the support pedestal for graffiti protection as a park will be built around the tank site in future years," Laird noted. Dur A Pell GS is a clear, silicone rubber-based graffiti protectant and water repellent, which protects vertical concrete block, brick, cast concrete, stone and other masonry substrates with little or no change to the appearance of the substrate. The concrete substrate was prepared in accordance with SSPC-SP13/NACE No. 6 Surface Preparation of Concrete prior to the application of these coatings.
