MARATHON CHEESE

A durable factory finish for the steel was a key requirement in the design and construction of the Marathon Cheese cooler building addition.

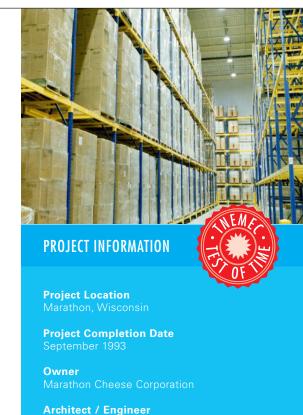
A durable coating system was needed to protect the steel in the Marathon Cheese cooler building addition.
