# WINDGAP BRIDGE

The Windgap Bridge in Pittsburgh, Penn. was painted in 1986 with Tnemec polyurethane coatings. While the original specification called for a phenolic zinc-rich primer, Tnemec's local coating consultant spoke with the contractor and engineer about a new Tnemec moisture-cured, zinc-rich urethane, Series 90-97 Tneme-Zinc. Benefits of Series 90-97 included superior corrosion resistance, a more user-friendly application and better curing tolerance at lower temperatures. All parties agreed to the change, and one of the first Series 90-97 projects was under way.

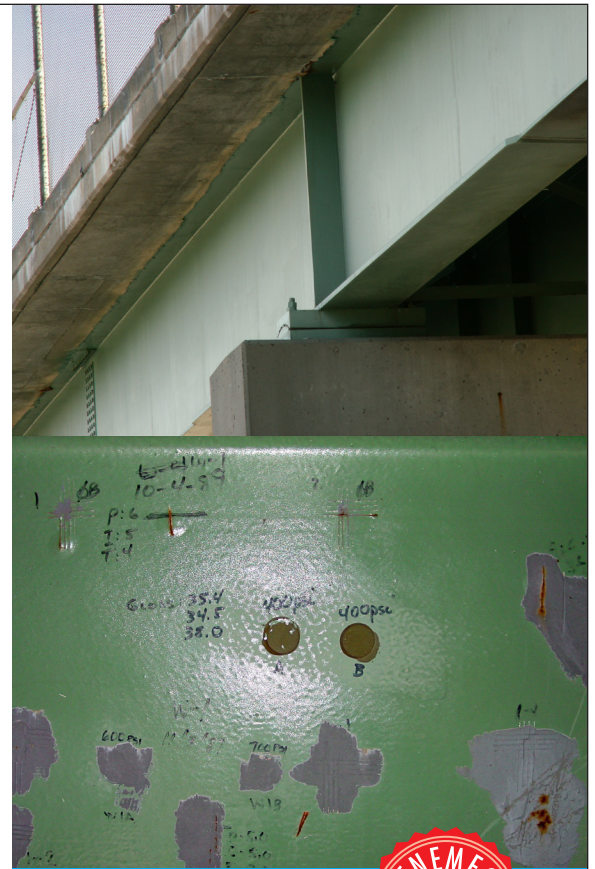
The photograph to the right was taken in 2007. After 20 years of service, the Tneme-Zinc/epoxy/polyurethane system is still performing extremely well. Note the gloss of the 20-year-old Endura-Shield finish coat.

The bottom photo shows the signs of an inspection that occurred in 1989. Note the reddish-gray Series 90-97 that was left untop-coated for 18 years. No corrosion has occurred other than where Series 90-97 was scratched away during destructive cross-hatch or Tooke gauge inspections. The confined rusting and lack of undercutting are a testament to the galvanic protection capabilities of Series 90-97 Tneme-Zinc.
